September 7, 2021

## Port Bay Barrier Bar REDI Project – Concept Plan Report

Wayne County Soil and Water Conservation District, Wayne County, NY

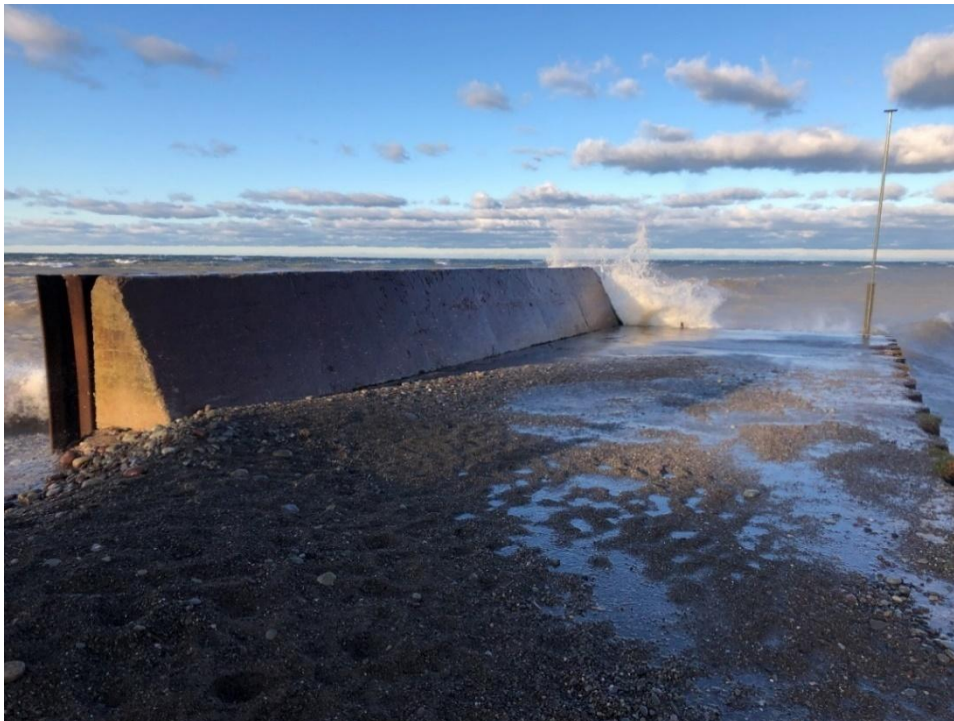
Figure 5 – West pier head and existing deflector wall (2 DEC 2020)

The plan includes encapsulating the west pier in steel sheet pile, adding a new concrete deck and preserving the 3-ft-tall concrete parapet wall (deflector wall). Presently gravel and cobble material is washed up and thrown over the lower elevation portion of the west pier and fills the navigation channel. Based on input from the PBIA during an August 18, 2021 meeting, a temporary (or removable) deflector wall (crest elev. 254 ft & approx. 65 feet in length) is proposed and will extend back towards the shoreline during the navigation season (May to September). By placing the deflector wall at this location, the sediment will now migrate to the head of the west pier and deposit off the northern tip. Land-based equipment will have access at the tip of the west pier for maintenance dredging operations. The removable deflector wall will consist of a pre-cast concrete block system and will be removed prior to the winter season.

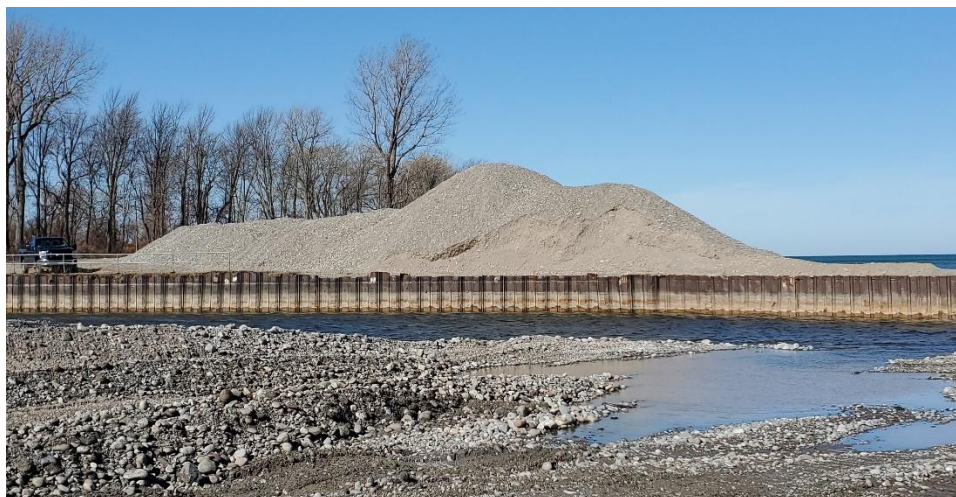
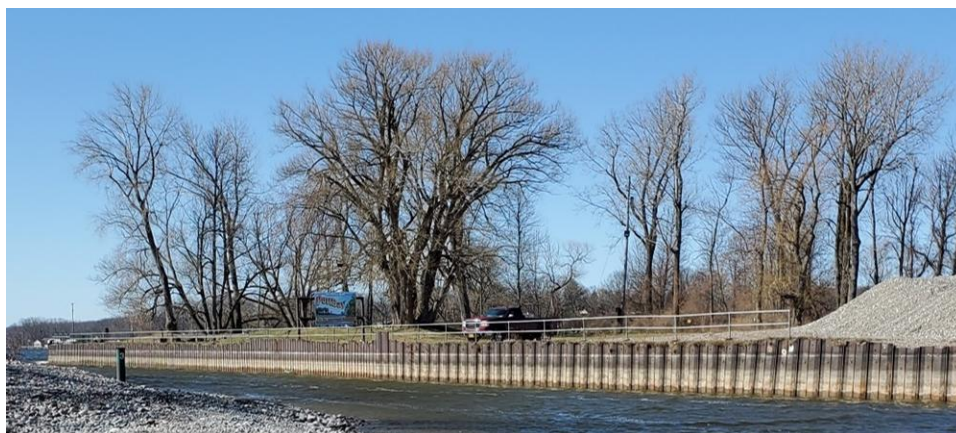
Figure 7 – Condition of sheet pile wall along channel (03 MAR 2021)

The remainder of the sheet pile wall, approximately 255 ft in length that continues to line the western side of the outlet channel, consisted of flat web 3/8" thick sheeting and is in fair condition with little deterioration observed along the waterline. The alignment of the sheeting appeared plumb, with no signs of instability or distress. The top of the sheeting was deformed locally, presumably from the initial driving of the sheet piles during original construction. At the very south end of the sheet pile wall the ground behind the wall has eroded away, exposing some of the anchor tie-backs, and has undermined the south end of the concrete slab landing that abuts the wall. A metal pipe railing is present along the top of the sheet pile wall along the majority of the wall length and is loose. The railing can be displaced several inches when exerted upon due to a loose connection to the sheet pile wall. The railing is in otherwise good condition.

The capacity of the anchored wall is developed by concrete deadman anchorages buried beneath the ground, which could not be observed at the time of the inspection. The only element of the tie-back anchor system observable during the inspection was the head of the anchor tie-back protruding through the face of the sheet pile wall. Various anchor head types were encountered along the site, with some consisting of a hooked reinforcing bar bearing against the sheeting face and, in other areas, a rod welded to a small bearing plate. The anchor heads appeared to be in poor to fair condition, with little uniformity in design at each anchor location, calling into question their reliability and quality of construction. Figure 7 and Figure 8 show the condition of the sheet pile wall along the channel.

Figure 8 – Condition of sheet pile wall along channel (03 MAR 2021)

The Bergmann team recommends keeping the old sheet pile wall intact and constructing a new anchored sheet pile wall in front of it. The thickness of the marine grade sheet pile wall itself is approximately 12" to 18". A gap of less than 2 ft is required between the new and old wall to provide driving clearance and room for an interior whaler to anchor the new wall. This will allow dredging activities adjacent to this part of the wall to continue as before. The wall will be designed to handle the load of heavy equipment adjacent to the wall.

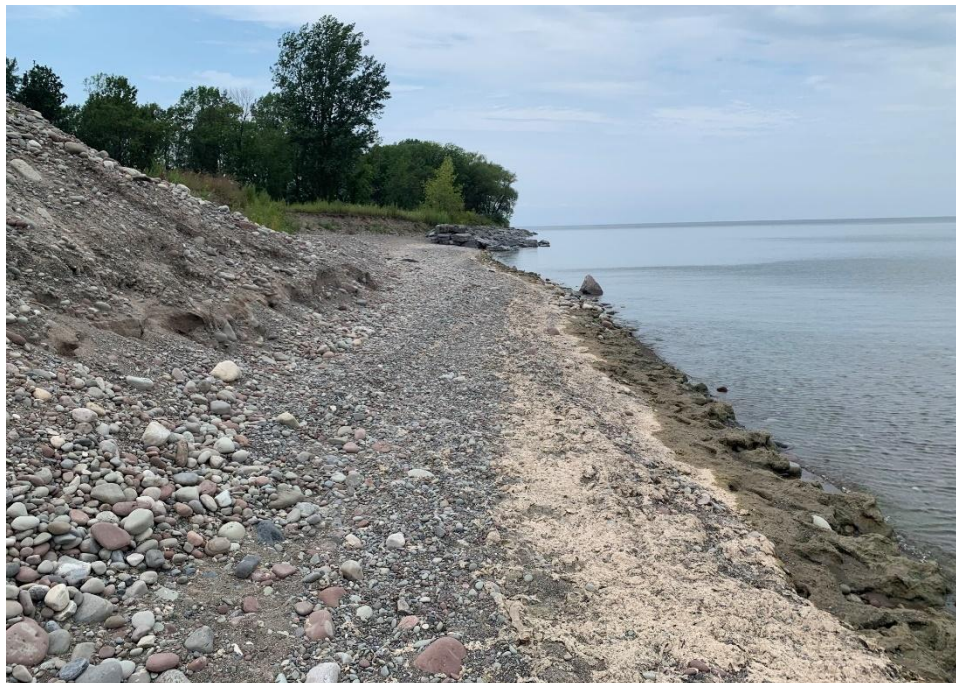
Figure 11 – "Gap" area between rock revetment and pier (looking west) 10AUG2021

The area between the end of the existing rock revetment and pier is known as the "gap" area for the purposes of this project (see Figure 11). The length of shoreline is approximately 250 linear feet. The water level at time of inspection on 10AUG2021 was 245.4 ft (NAVD 88) based on the NOAA gage at Oswego Harbor.

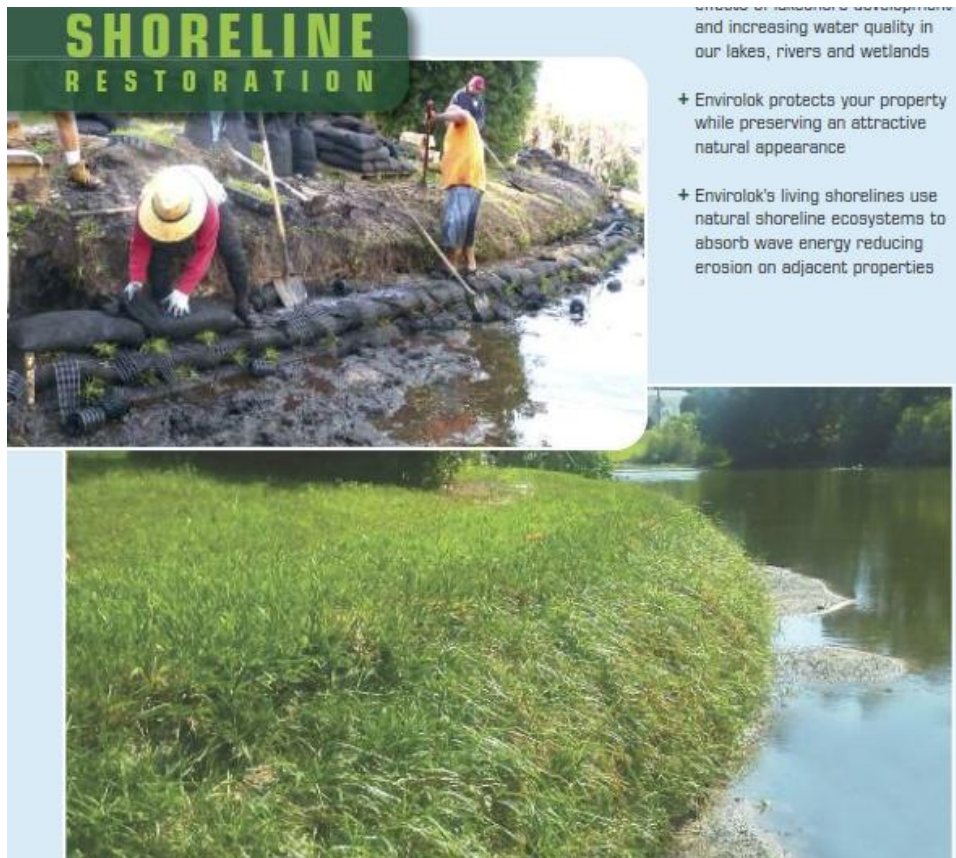
Figure 13 – Excerpt from Envirolok brochure

The bay side of the west bar access road is subject to erosive forces when water levels are high and wave events overtop the western bar. Envirolok bags are currently being investigated as a potential stabilizing solution. Envirolock bags provide stability and allow vegetation growth, which eventually masks the bags and takes on the appearance of a vegetated slope. An excerpt from the Envirolok brochure is shown in Figure 13. Further investigation is needed to determine the most appropriate green solution for this area. The desire is to protect the bayside shoreline and provide additional opportunities for aquatic habitat.

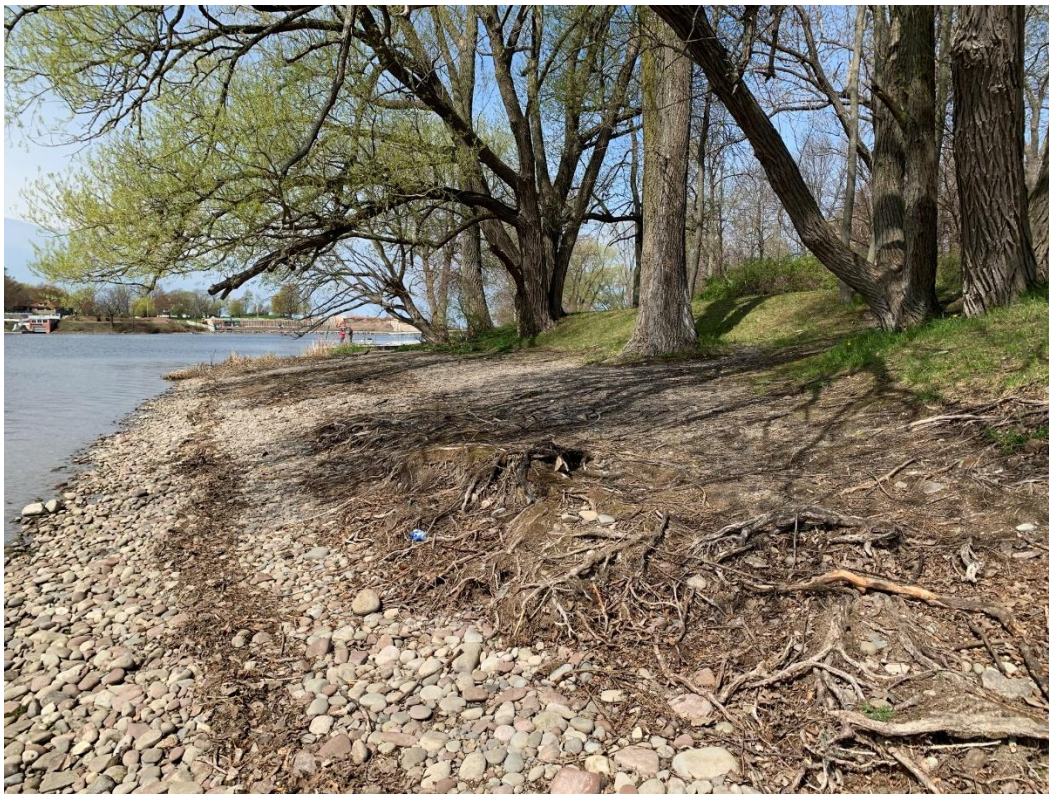
Figure 15 – Area of exposed tree roots ~ west bar bayside (03 MAY 2021)

In addition, there is a group of trees along the bayside on the west barrier bar with roots exposed (Figure 15). During high water, this tree area/ shoreline is inundated and threatens the stability of the trees. The Bergmann team will investigate bank stabilization measures to ensure tree and bank stability in the next phase of the project.

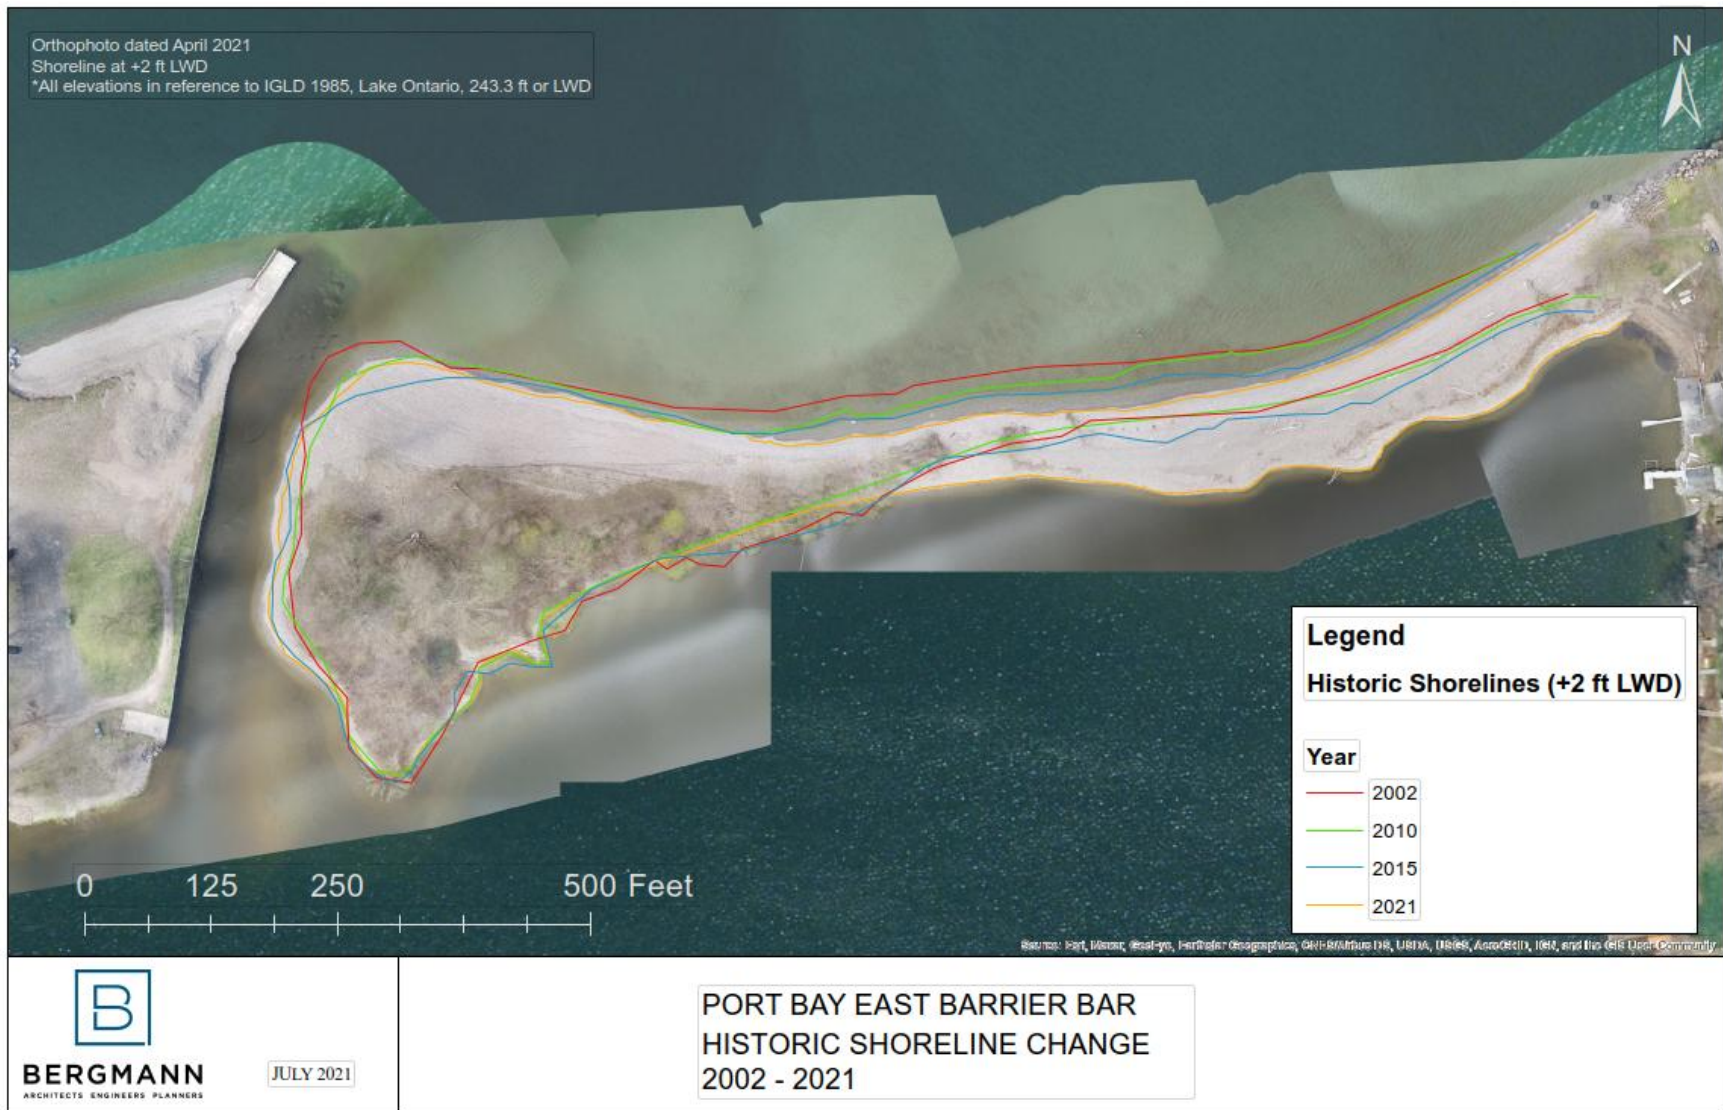
Figure 16 – Port Bay East Barrier Bar Historic Shoreline Change 2002 – 2021

Figure 17 – Port Bay East Barrier Bar Shoreline Change 2010 -2002 (8 years)

Figure 18 – Port Bay East Barrier Bar Shoreline Change 2021 -2010 (11 years)

Figure 19 – Port Bay East Barrier Bar Shoreline Change 1965 & 2021

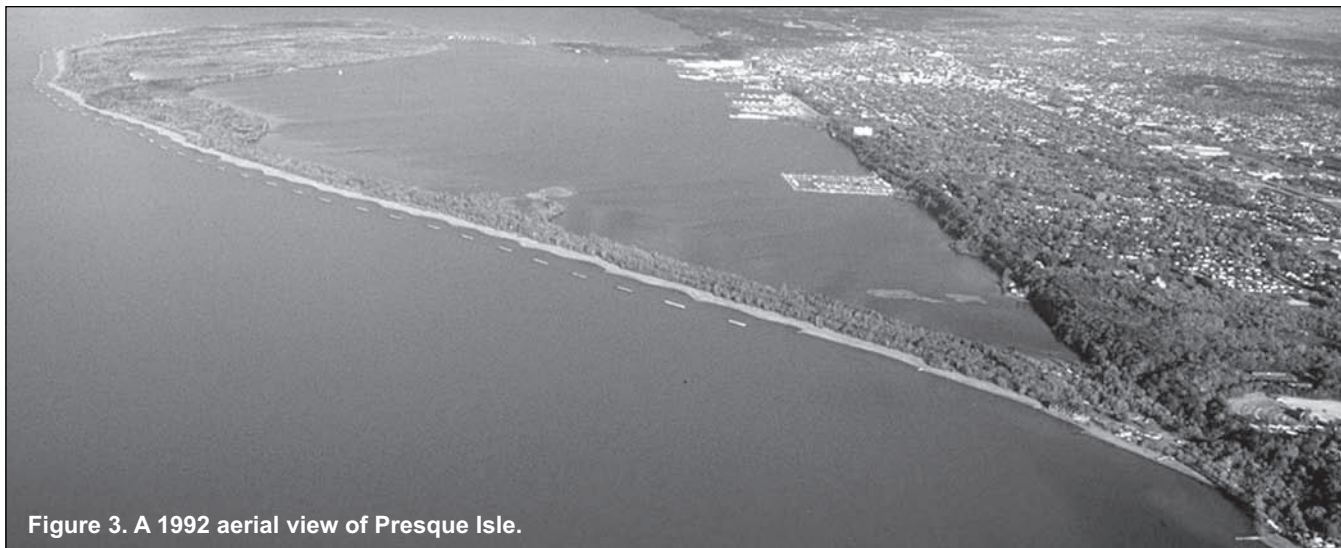
Figure 3. A 1992 aerial view of Presque Isle.

The large quantities and cost of beach nourishment needed (160,000 to 172,000 cu yds annually), prompted the Commonwealth of Pennsylvania to request an evaluation of this practice in 1968. Numerous alternatives were considered including no action, nourishment alone, nourishment and sand recycling from the east end of the peninsula, and a variety of structural configurations with nourishment. Section 501(a) of the Water Resources Development Act of 1986 (Public Law 99-662), authorized and funded the construction of 58 offshore segmented rubble-mound breakwaters (55 were built) with initial placement of 373,000 cu yds of sand fill. The design included beach berms with average widths of 75 ft and crest elevations of 10 ft above LWD. Existing shore protection structures were removed prior to construction. The plan also provided for annual nourishment of approximately 38,000 cu yds of sand fill. The breakwaters are 150 ft long with crest elevations of 7.8 ft above LWD and are separated by 350-ft gaps. Construction began in October 1989 and was completed in November 1992 (Figure 3). A more complete description of the project may be found in Mohr (1994).

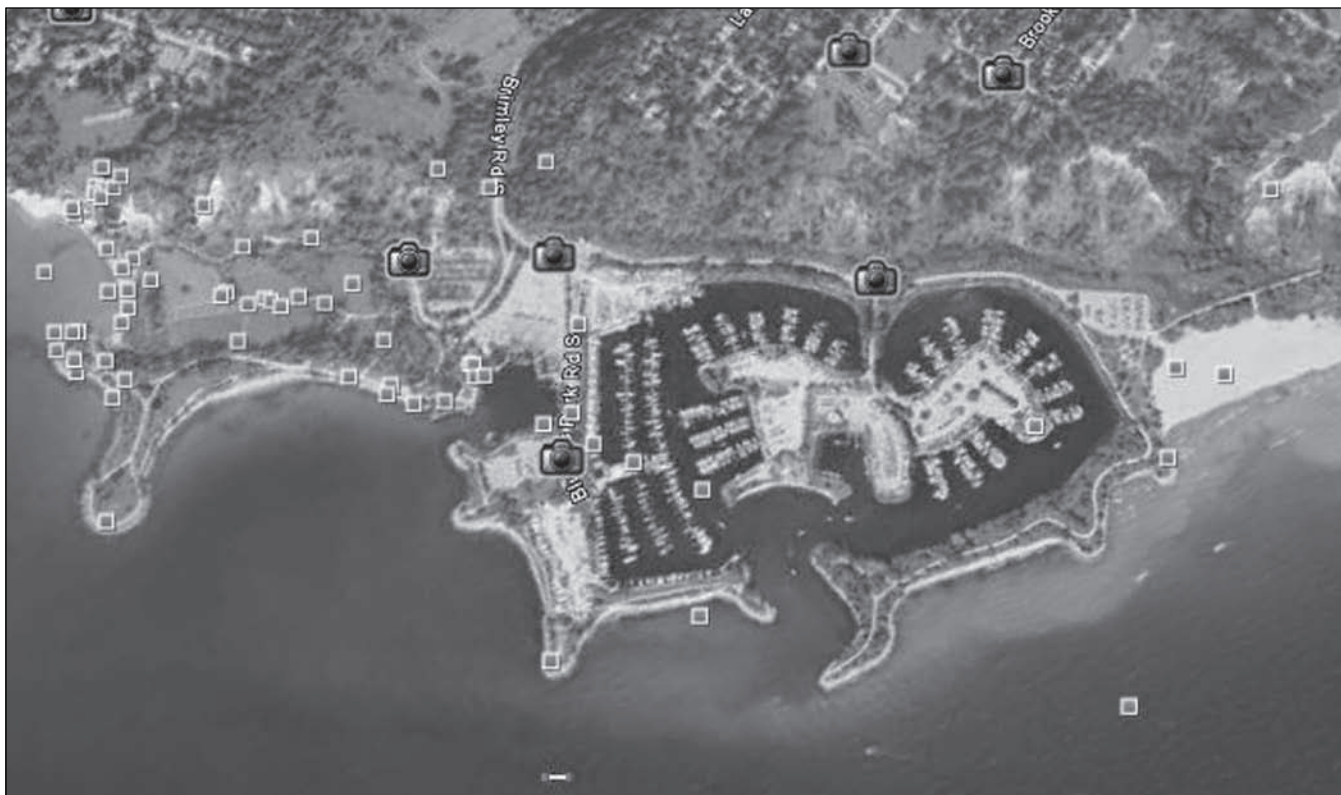
**Figure 5. Built on reclaimed land in Lake Ontario east of Toronto, Bluffer's Park first opened in 1975 and was expanded to its current size in the early 1980s. The park is home to four sailing clubs. Note 100-ft scale bar and armored headland on left (Google air photo 2009).**

Western Lake Ontario has a long history of engineered coastal structures. The Toronto metropolitan area waterfront is characterized by lake fills (Figure 5) and headland-protected beaches. According to the Ontario Ministry of the Environment (Persaud 2003):

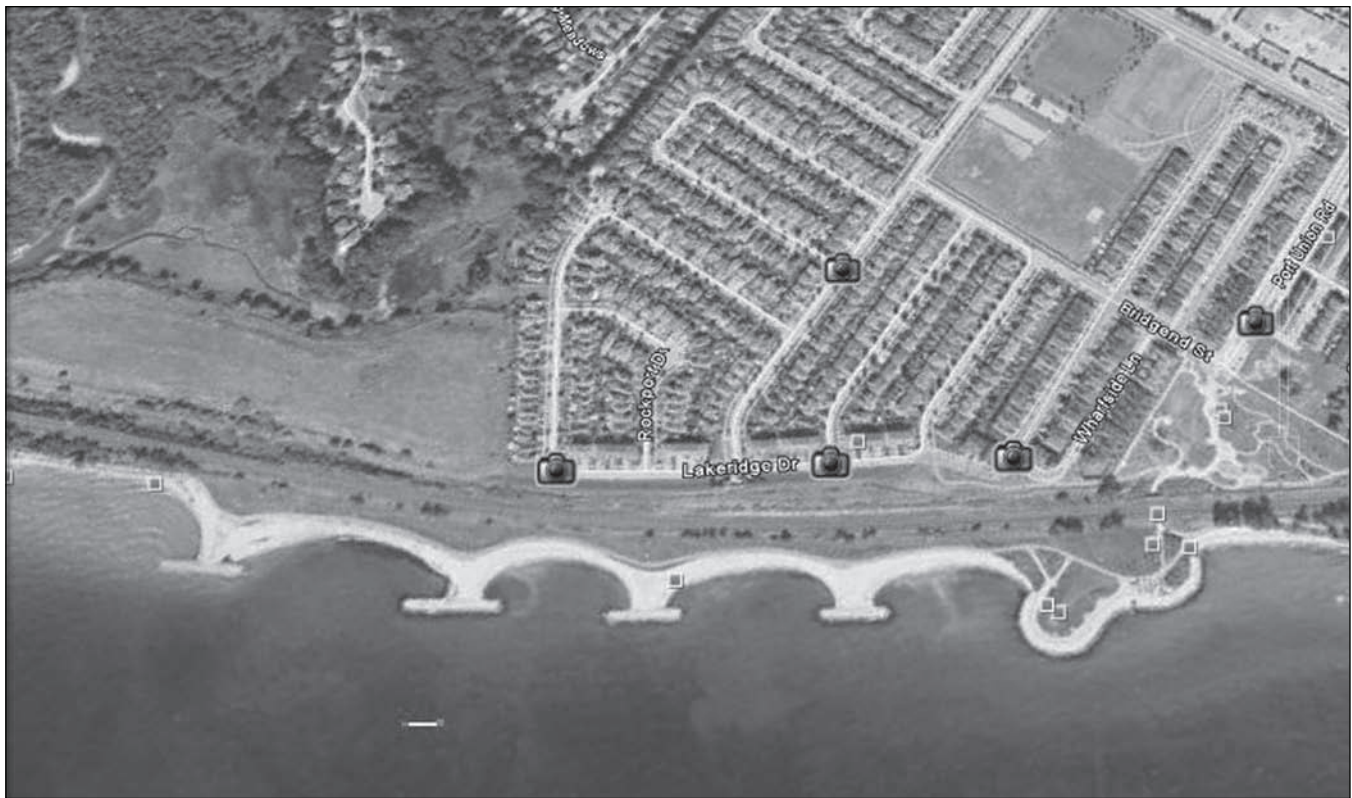
**Figure 6. Armored headland and attached breakwaters constructed in 2005-2006 to protect public beaches in Port Union, Ontario. A second system was constructed about a half mile to the north in 2009. Note 100-ft scale bar (Google air photo 2009).**

Armored headlands and breakwaters are a prominent form of beach protection in Toronto and include two systems constructed in 2005 and 2009 in Port Union, Ontario (Figure 6). Planned and constructed by the Toronto Region Conservation Authority, the beach systems are being monitored for impacts to the littoral system and fisheries (Ontario Ministry of the Environment 2000). As the shorelines are nearly fully engineered and the structures well-designed, impacts are likely to be minimal. More importantly, the government is committed to monitoring and remediation if necessary.

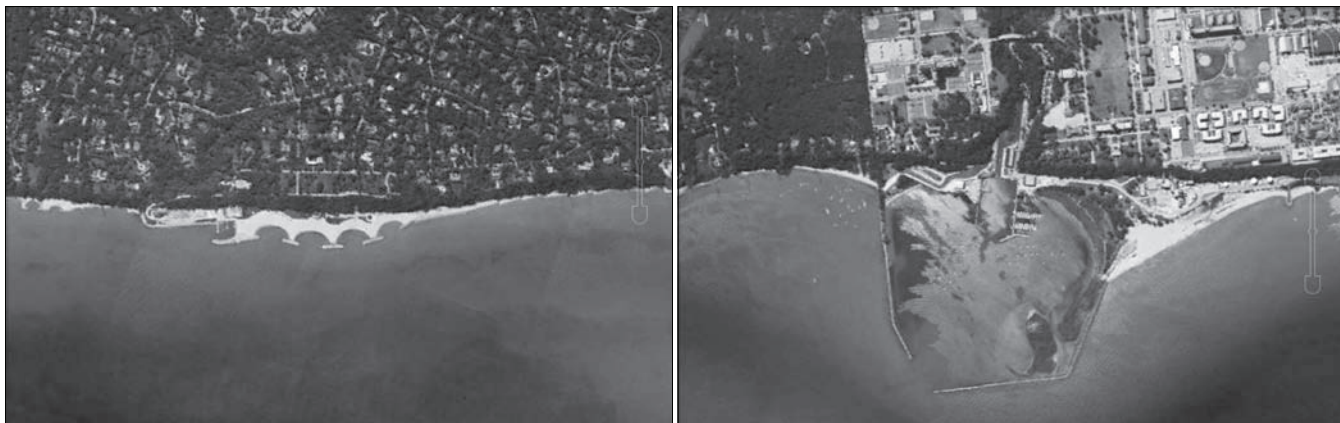
**Figure 7. View of the largest headland-protected beach in Lake Michigan at Forest Park Beach in Lake Forest, Illinois (above). The system lies within the surf zone, extending about 400 ft from the bluff toe into the lake. In comparison, 3.5 miles updrift (north) is Great Lakes Naval Training Center Harbor (below) that was, for nearly a half century, a total littoral barrier. The breakwaters, built in 1923, protrude 2,400 ft into Lake Michigan. Between 1923 and 1976, approximately 2.5 million cu yds of sand was impounded in the harbor and on its updrift side (Chrzastowski and Trask 1995). 2007 Google photos both to same scale.**

In the mid 1980s, the city of Lake Forest hired W.F. Baird and Associates to design and engineer a sustainable beach to replace the failing groins at Forest Park Beach. In addition to numerical analysis, a physical hydraulic model of the system was conducted in order to maximize the probability for success of the project. Designers assumed littoral drift in this coastal cell would be negligible (Anglin *et al.* 1987). This is not surprising as Great Lakes Naval Training Center Harbor, 3.5 miles updrift, was considered a total littoral barrier (Figure 7). Based on results of the model, five attached breakwaters were built in depths of up to -11 ft LWD, 180 ft lakeward of the preconstruction shoreline (Figure 7). The four north beach cells were filled with 200,000 cu yds of 2.8 mm fine gravel "birdseye sand" that the engineers anticipated would be more stable than the native medium sand (Anglin *et al.* 1987). State regulators required as-built and post-construction surveys to assure no negative impacts. Monitoring consultants recommended an additional 20,000 cu yds of sand be added immediately downdrift of the site prior to project construction as insurance that the littoral stream would not be disrupted by the work (Dean and Seymour 1986). Although this was not done, it is noteworthy that the Illinois DNR now recommends a 20% sand overfill for projects, both public and private, that may trap sand.
